Appendix F – Wetland Reconnaissance Letter

RE: Wetland Reconnaissance for Bow Lake Transfer Station and WSDOT Property, Tukwila, WA

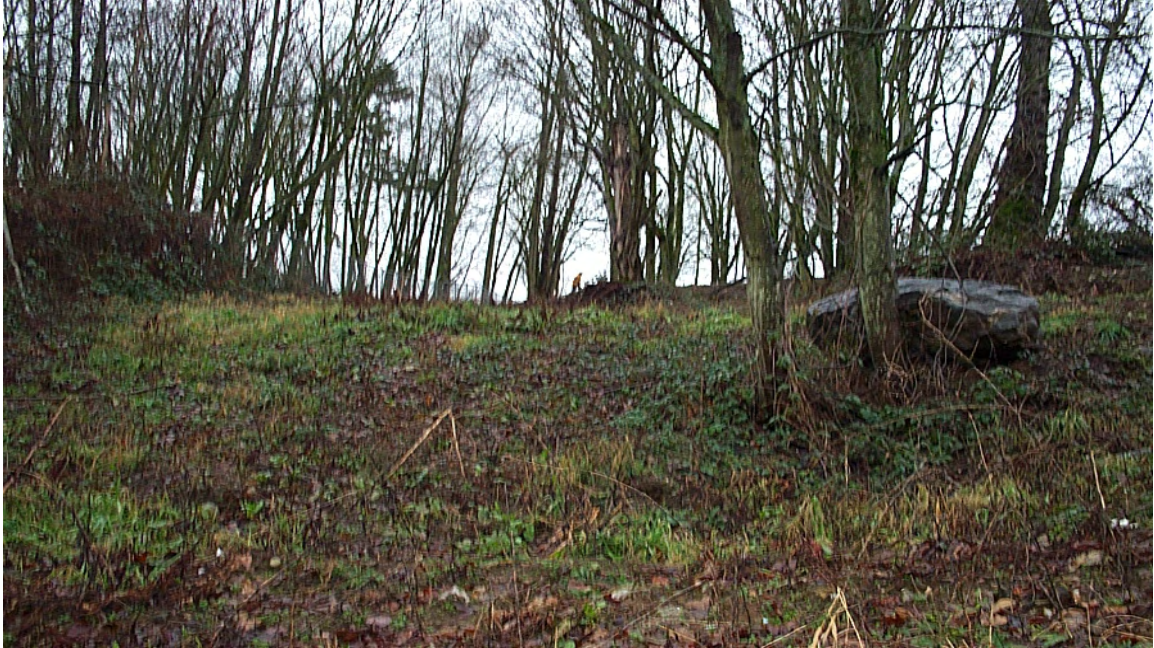
No wetland areas were identified during the January 2004 site visit. The potential wetland previously identified during the 1998 reconnaissance no longer meets wetland criteria due to removal of the culvert outfall. One wetland plot (Plot 1) was taken in the previously existing wetland and another (Plot 2) was taken approximately 200 feet down-slope of Plot 1 (Figure 2). Photos one and two document conditions in this area.

Soil in Plot 1 was comprised of a sandy loam fill material (2.5 Y 4/2) with mottles and was saturated due to compaction. This area was obviously disturbed and contained non-native fill material. The water table was reached at a depth of 15 inches. Vegetation consisted of reed canarygrass (*Phalaris arundinacea*), Himalayan blackberry (*Rubus procerus*), cleavers bedstraw (*Galium aparine*), and agrostis (*Agrostis alba*), black cottonwood (*Populus balsamifera*), big-leaf maple (*Acer macrophyllum*), and red alder (*Alnus rubra*). This plot contained hydric soils and hydrology (in the winter), but lacked the necessary wetland vegetation to be considered a wetland. It should also be noted that

PHOTO 1. Bow Lake Transfer Station, Vegetation in proximity to Plot 1 and Plot 2 (1/15/04).

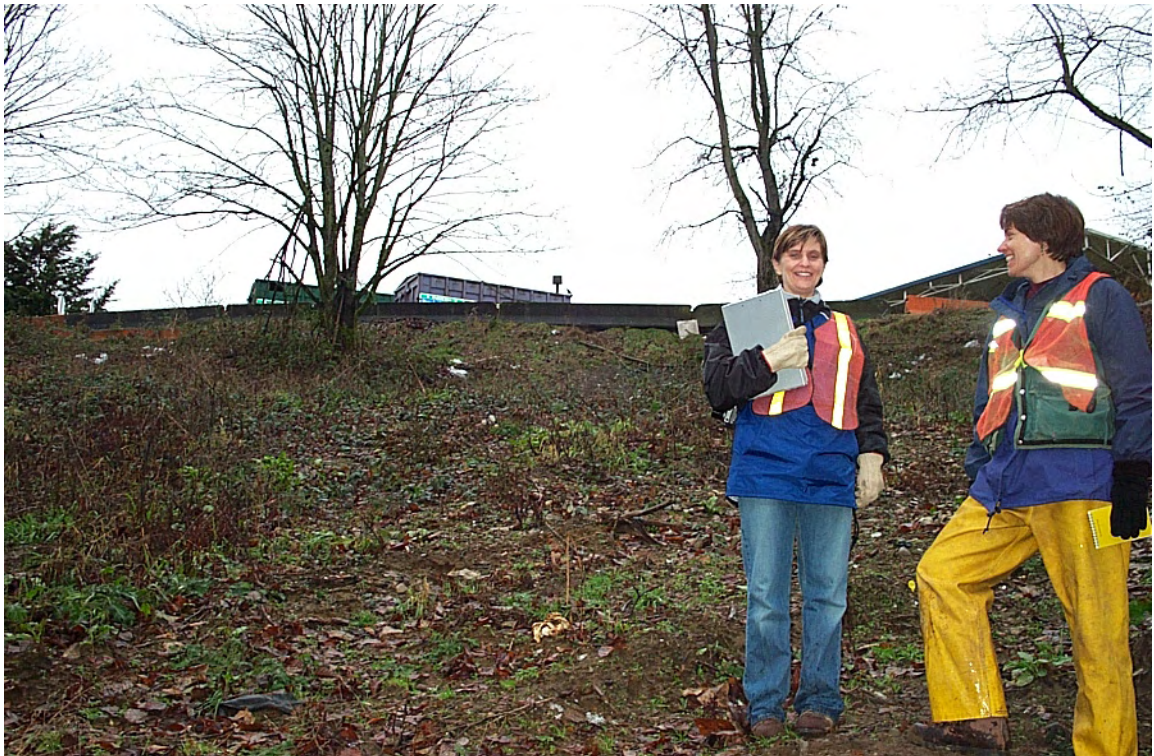
PHOTO 2. Vegetation facing uphill (NW) toward transfer station (1/15/04).

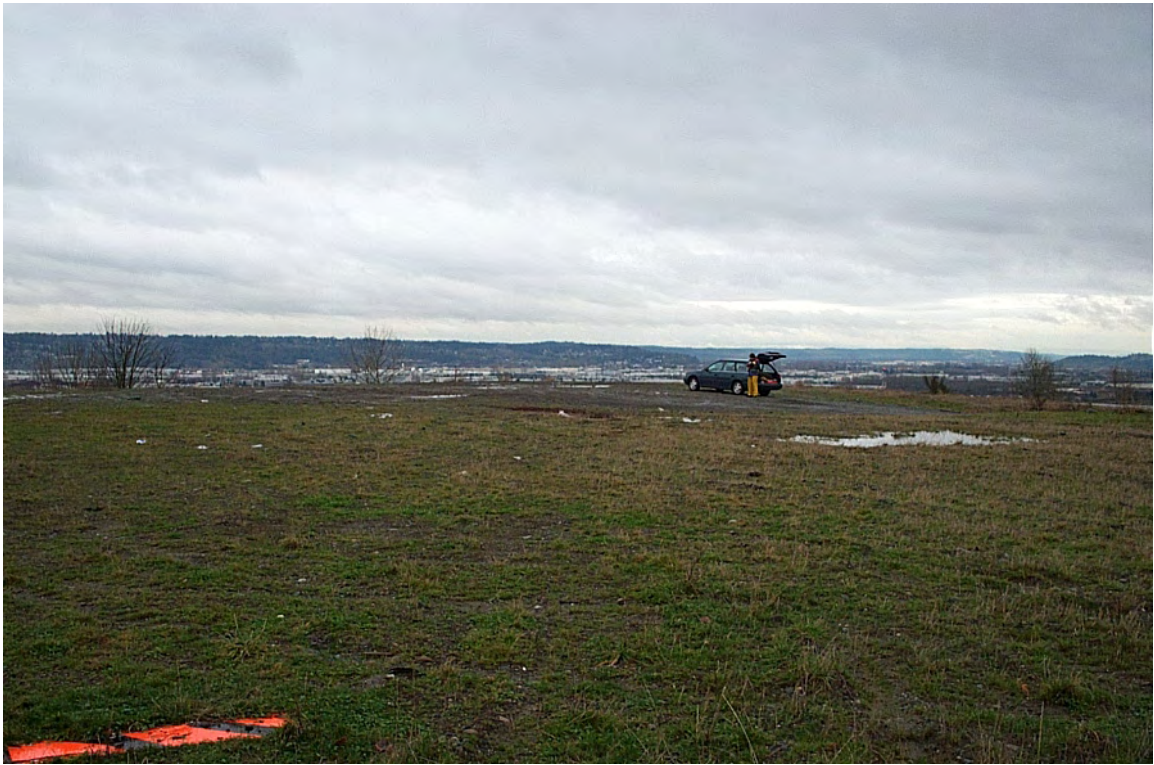
Adolfson also surveyed the WSDOT site north of the transfer station facility. The WSDOT site was surveyed to the forested perimeter on the north side, to the eastern edge of the lower bench (eastern edge of blackberry thicket), to the Bow Lake Transfer Station to the south, and to I-5 to the west. The site is comprised of two parts or benches. The WSDOT site is higher in elevation than the Bow Lake Transfer Station Site. The upper-bench was created by the historical disposal of construction spoil material, and the lower bench was created by the disposal of burned refuse material (Hufnagel, personal communications, 2004). The upper bench is highly compacted resulting in water collection at the surface (Photo 3). The soils were not considered hydric (compacted fill material), there is no evidence of hydrology, and vegetation on the disturbed upper bench consists mainly of grasses and weeds while the lower bench is primarily Scot's broom (*Cytisus scoparius*), Himalayan blackberry (*Rubus procerus*), and young red alder (*Alnus rubra*).

PHOTO 3. Upper bench of WSDOT property looking SE toward Kent (1/15/04).

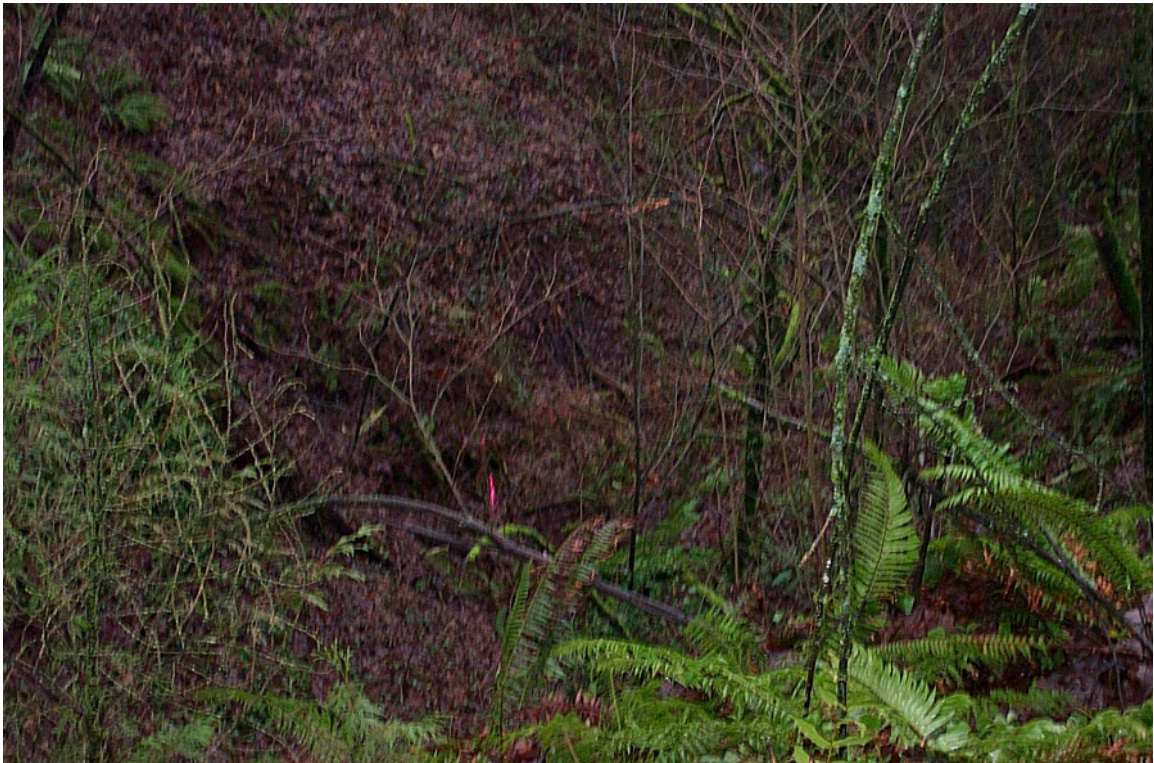
In addition, it was also noted that a stream appears to cross the northern portion of the WSDOT property (King County GIS; Figure 1). The stream exists within a steep slope forested ravine north of the disturbed area and is currently receiving stormwater runoff from I-5 (Photo 4). It appears that the discharge area has created landslides in the past, and has created dangerous undercut banks at the top edge of the slope. Wetlands may be associated with the bottom of this ravine near the stream; however, this area was not surveyed. It appears that both the stream and associated steep slope buffer are located on the WSDOT property.

PHOTO 4. Ravine w/stream and steep slopes just north of WSDOT property (1/15/04).

Sensitive areas within the proposed improvements to the Bow Lake Transfer Station are regulated by Tukwila Municipal Code (TMC) Title 18 - Zoning. According to TMC 18.45.020, the ravine area containing a stream, steep slopes, and landslide evidence is likely considered an Area of Potential Geologic Instability with a ranking of Class 3 or 4. According to TMC 18.45.040 (Sensitive Area Buffers), a geotechnical report may be required to identify appropriate buffer widths in relation to activities proposed pursuant to the requirements of TMC 18.45.060 and 18.45.080E.4. Standard stream buffers in the code range from a 15-foot-wide buffer for a Type III stream to a 70-foot-wide buffer for a Type I stream.
